City of Baltimore Wet Smoke and Dyed	Page 1 of 2	
Sewershed: Gwynns Falls	Company: Savin	Date: 4/21/2009
Test to be performed:  Smoke Dyed Water X Dry ✓ Damp ☐ Wet ☐		Supervisor: <u>JAW</u>
Manhole_ID: S03K_013MH	Test ID: <u>D1032-002005</u>	Notification Made: NA (Residents, Fire, 311)

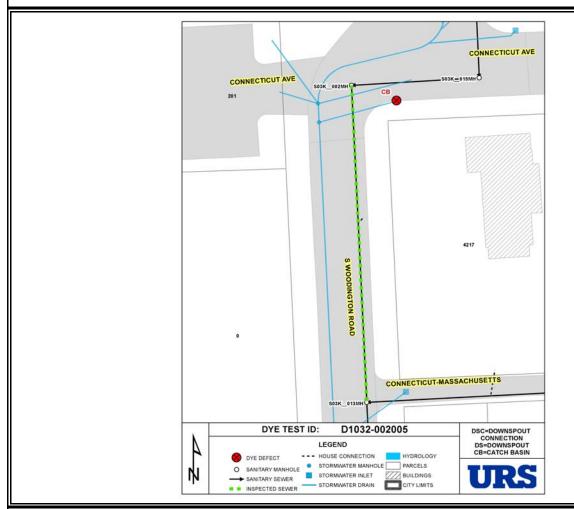
Field Sketch: Show all manholes with Numbers, Blower Placement Locations, Sandbag or Isolation Locations, Street Names, Building Addresses and Locations, Defect Locations and Photo Numbers.

Defect Loc	Obs_ClockFrom	Obs_ClockTo	Observation	Obs_Remarks
0			Start of Survey	
0			Manhole	S03K002MH
9			Dye Test Visible	@ FC & IR, 1 GPM
11.39999962			Dye Test Visible	@ FC & IR, 2 GPM
27.79999924			Dye Test Visible	@ IR, 1/2 GPM
35.79999924			Dye Test Visible	@ IR, 1/8 GPM
37.79999924			Dye Test Visible	@jt, 1/4 GPM
43.59999847			Dye Test Visible	@ jt, 1 GPM
49.79999924			Dye Test Visible	@ IR, 1/4 GPM
52.5			Dye Test Visible	1/4 gpm
55.70000076			Dye Test Visible	@ IR, 2 GPM
